UNITED STATES ENVIRONMENTAL PROTECTION AGENCY
REGION III
1650 Arch Street
Philadelphia, Pennsylvania 19103-2029

Inspection Date(s): 9/18/2017 – 9/21/2017

Company name: Antero Resources

Facility Name: Hamilton, Estlack, Weigle East, Eddy, Primm, Robert Williams, Fritz, Lockhart Heirs, Charlene, Walnut West, Diane Davis, Ness, John Richards, Edwin, Mackay, and Rock Run well pads

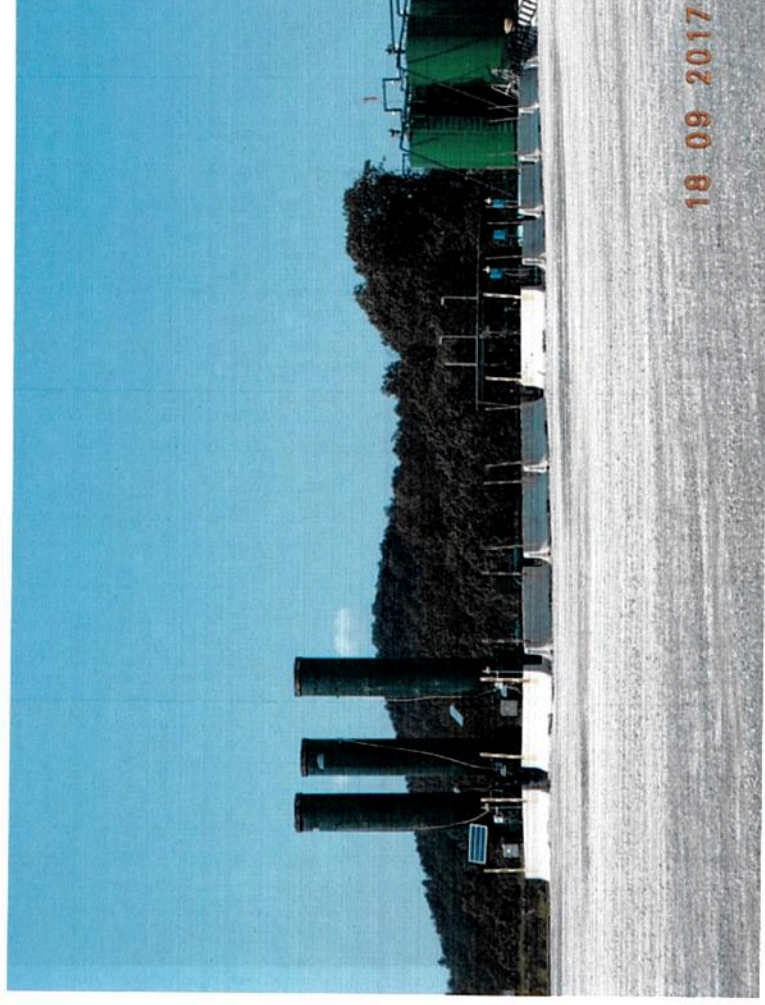
DSC00531 Estlack Flares

EPA arrived at the next site, Estlack wellpad, at 11:44 am. The site consisted of ten wells and GPUs, twelve tanks, three enclosed combustors, and five vapor recovery towers. The combustors appeared to show excess emissions when viewed with the FLIR camera. The combustors had the following characteristics:

Estlack Enclosed Combustors	
Unit ID	Operating Temperature (°F)
1378191	~250
1378189	~250
1378197	~250

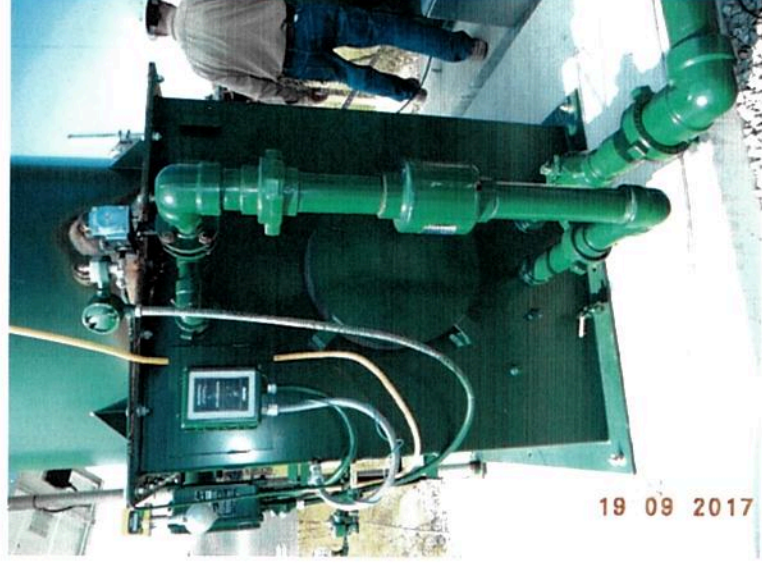
DSC00539 Primm Flare and Vent Gas Inlet

The following day, September 19, 2017, the inspection resumed at 10:21 at the Primm Wellpad. This site has eight wells, eight storage tanks, and eight GPUs, and two enclosed combustors. EPA surveyed those components with the FLIR camera and found that there appeared to be excessive emissions from the enclosed combustors. Enclosed combustor ID numbers and operating temperatures are shown below:

Primm Enclosed combustors	
Unit ID	Operating Temperature (°F)
1378133	373
1363528	195

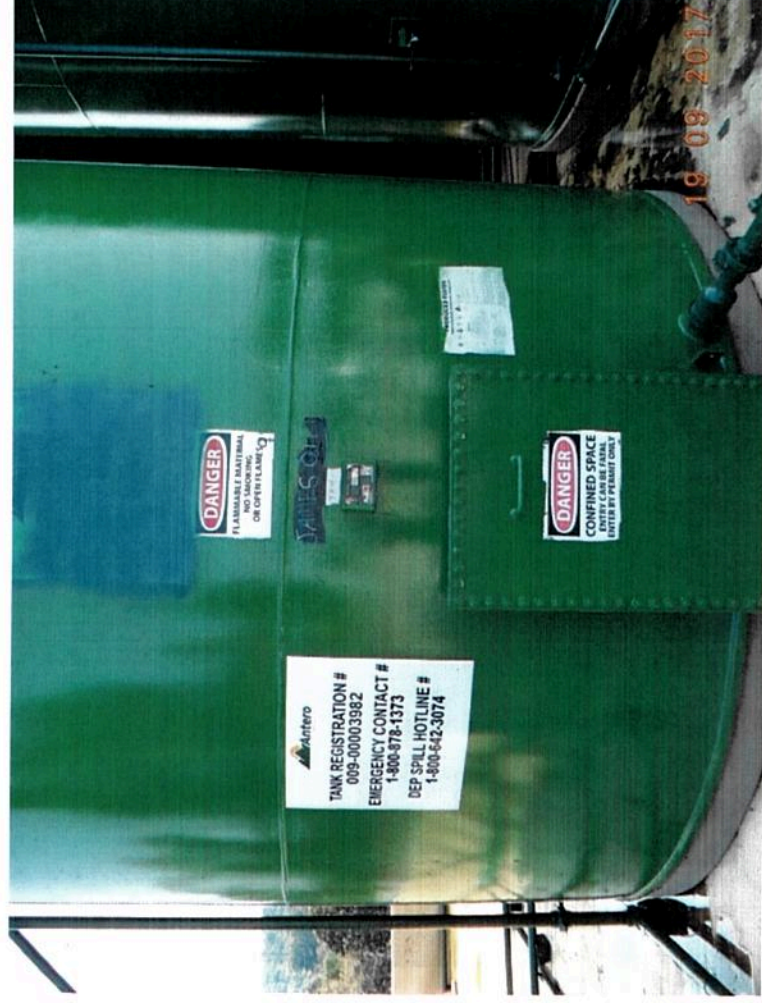
DSC00541 Robert Williams Tank

At Robert Williams, emissions were observed at the top of tank 009-00003982. The tank contained produced brine water and condensates. Antero representatives repaired the leak by tightening a hammer union; no emissions were detected afterwards. No other equipment emissions were identified at this site in either the wellheads or GPUs. The enclosed combustor at Robert Williams, unit ID 12363526, was pulsing and EPA noted it was operating at 84°F. FLIR video of the combustor appeared to show excessive emissions. EPA left the site at 11:52 am.

EPA also noted that the inspection revealed one small excess emission at the Robert Williams wellpad storage tank that was repaired on site. Additional emissions from equipment was found on vapor recovery units at the Estlack and Mackay wellpads.

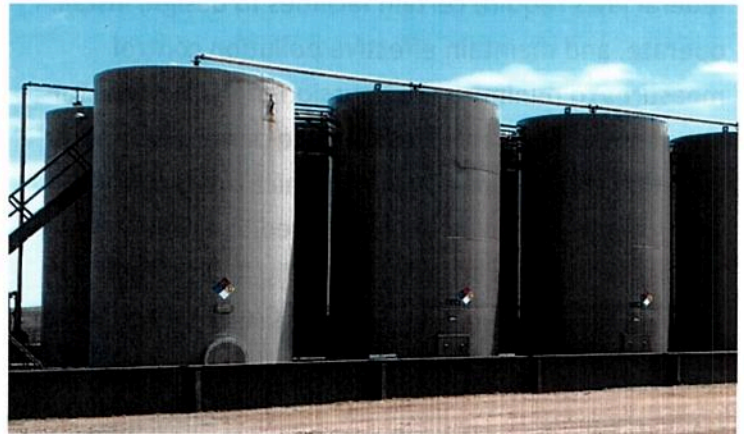
and natural gas is extracted from sub-surface formations through a wellhead and then flows into a separator at varying pressures. The separator divides material from the wellhead into various constituents, such as oil, water, hydrocarbon liquids and natural gas or comingled

Storage vessels at an oil and gas production facility.

liquids and natural gas, depending on the characteristics of the well. The separator has a valve that opens to "dump" the pressurized liquid into a storage vessel.

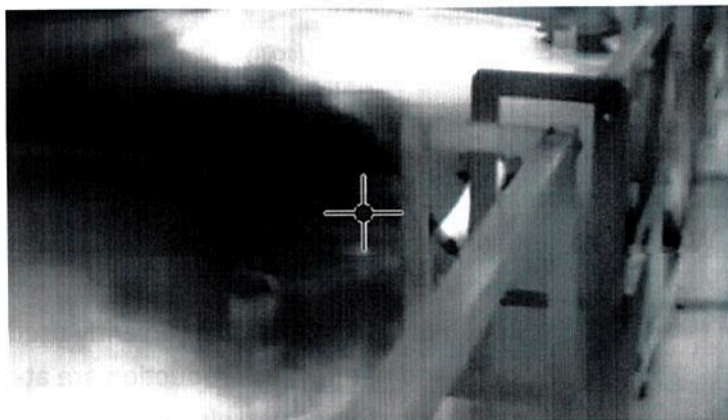
EPA and state inspectors have observed emissions from storage vessel PRDs, such as closed thief hatches and pressure relief valves. Inadequately designed, sized, operated, and/or maintained vapor control systems may not effectively capture and control emissions.

Infrared video image showing emissions from a thief hatch on a storage vessel.

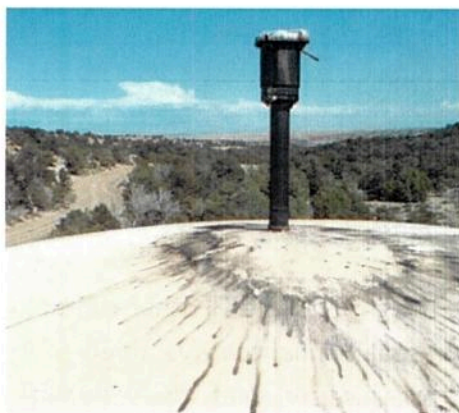
Hydrocarbon staining under a PRV indicating storage vessel over-pressurization.

PRVs function as safety devices to protect against structural damage that can result from over-pressurization and should not open during normal operations. A PRV should be selected, installed, and maintained to ensure proper functioning as an emergency relief valve to

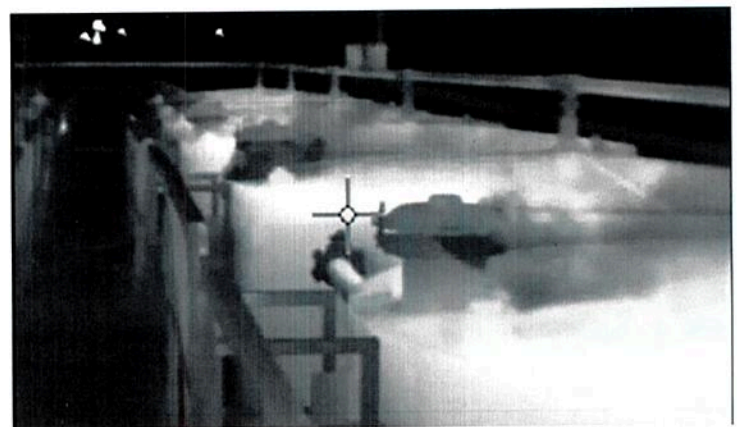
Infrared video image of thief hatch emissions.

To minimize emissions from closed thief hatches, operators should install quality thief hatch gaskets that are compatible with the liquids stored and regularly inspect,

maintain, and replace the gaskets and all other contact points to ensure a tight seal. Similar to PRVs, thief hatches will open at a pressure set point. The set point should be set low enough to protect against storage vessel over-pressurization and high enough to avoid open-
